Distributor Rotor Cap Anomalies

By Ron Dill

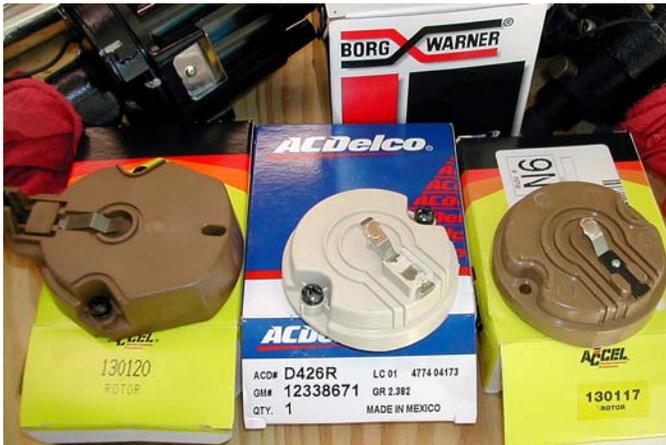
You'll notice there are two Accel rotor caps in the picture – the one on the left (Part # 130120) is not correct. It was clearly meant for one of the later model electronic ignition systems – I offer it only for comparison. I spent an hour on the phone with the guy as he researched numbers and finally concluded that 130120 was just what I needed, so I ordered it. Clearly, he was mistaken.

The Accel cap on the right both feels and looks more substantial than the Delco cap in the middle. I wouldn't say that the Delco cap is flimsy – but, compared to the Accel cap it is.

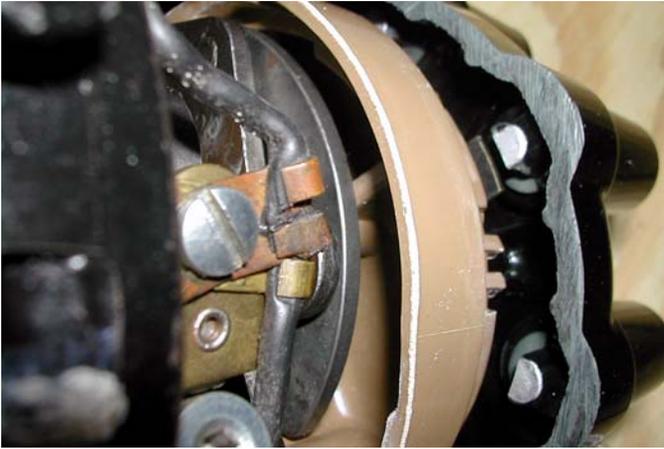
I pulled out my stash of spare distributors and started my test with a '62 340 horse (1110985) unit. I installed the white Delco rotor button and my new Borg Warner cap. As best I could determine, the spark gap was approximately .105".

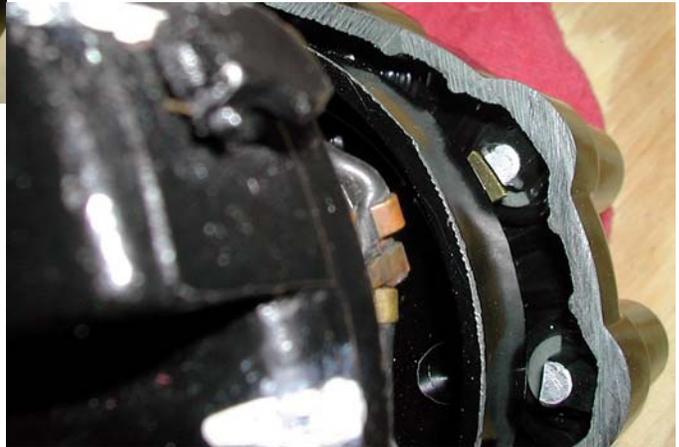
Now I installed the Accel rotor and measured a clearance of .088" a difference of .017". You can tell from the picture that the gap is not nearly as large.

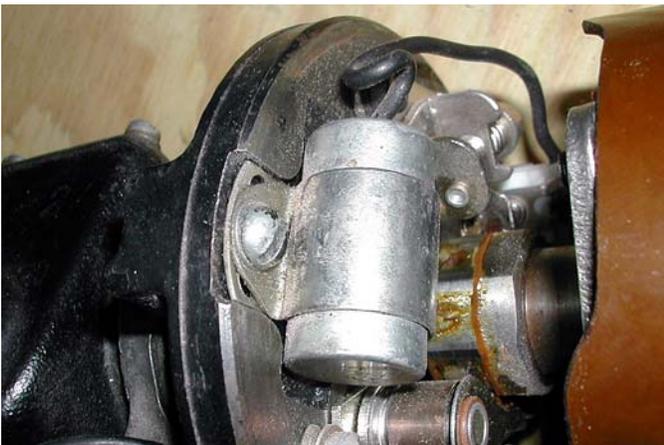
I was a little troubled by the fact that the pointer on the original button actually touched the post on my test distributor cap so I decided to investigate that issue a little more. I reinstalled the original rotor and distributor cap and found that the pointer hit the post in this configuration as well. At this point I thought – good thing I tried this out before putting it in the car!! Had I set the points and installed the distributor and tried to start the car I would have created problems by either wrecking the rotor cap or the distributor cap, or both. *(I'm not sure that you would notice that the cap didn't fit right if you were installing it on the car – between the plug wires and everything else in the way, you tend to assume that everything is OK if the cap notch went in the slot and both clamps/latches are latched.)*

Further investigation revealed what was causing the problem. There is a screw head located close to the edge of the distributor that holds down the condenser. That screw head does not allow either the Borg Warner or the old distributor cap to seat down properly as it hits the plastic near one of the cap hold down clamps. I assume the original distributor caps were probably produced with a slot in the cap to prevent this interference. At any rate, I tried a flatter headed screw – no luck.

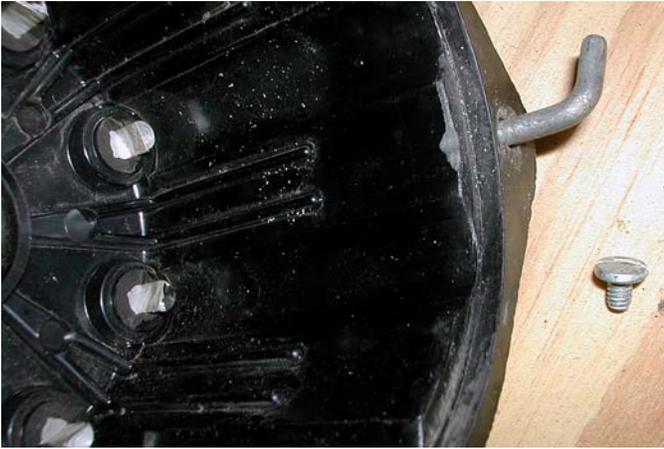
You can see from the picture of the cap that there is a lighter colored wear mark near the latch where the screw head was hitting the cap.

So, out comes my handy dandy Dremel tool and I ground out enough of the cap plastic to clear the screw head.

This allowed the cap to fit down properly and I rechecked the clearance.

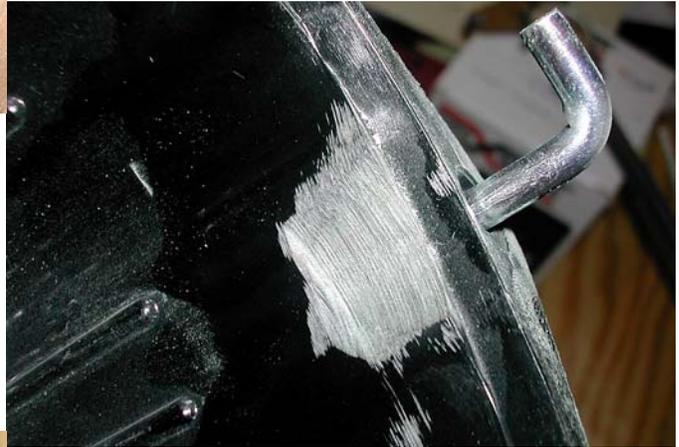
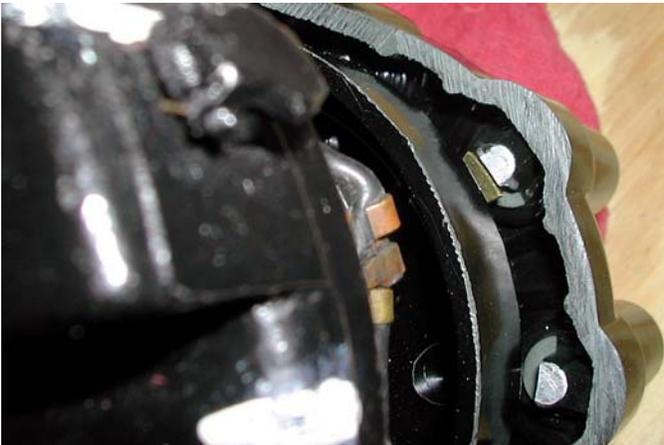
With the improved fit on the cap and the original black rotor cap, the clearance was something under .025". Because of the curved surfaces, I wasn't able to measure it exactly. But, from the picture you can see that the clearance is dramatically smaller.
