2X4 MANIFOLDS

By Ron Dill

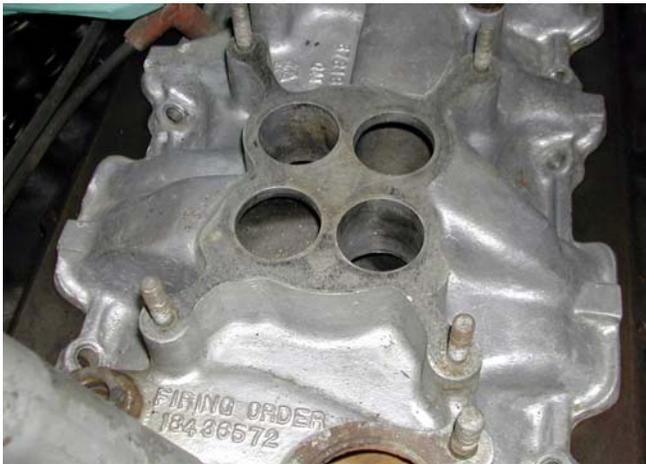
Aside from the part numbers, there was one major difference between the two most common manifolds. The '56 manifold (3731394) had four distinct holes for each carb.

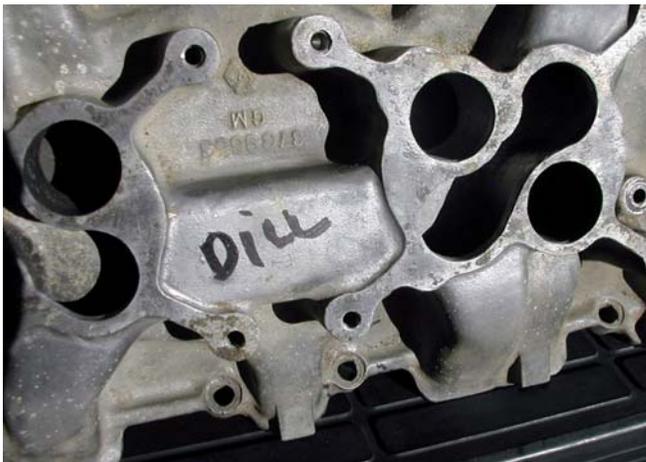
The '57 – '61 manifold (3739653) was changed at the factory to give better efficiency. You can see that the aluminum has been removed between the holes. And, as you can see in this picture, the part number and GM, as well as the snowflake mark are between the two carb bases. This and the firing order found near the oil filler tube are the only obvious markings on the top of the manifolds.

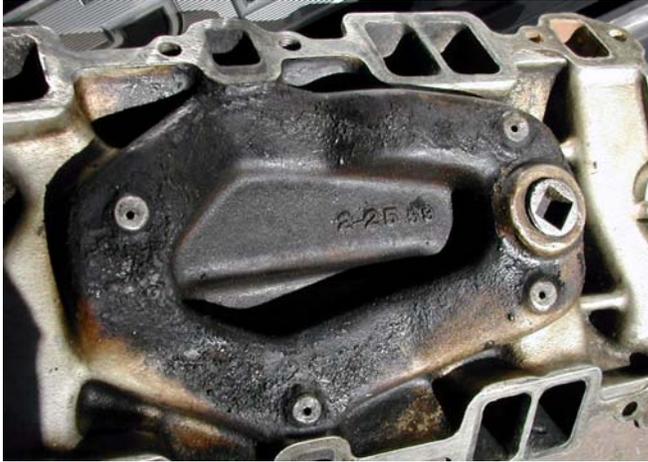
The manifolds are date marked on the bottom side. The marking is under the oil shield which is pinned to the bottom of the manifold. The shield has been removed from this manifold so that you can see the date mark of 2-25-59.

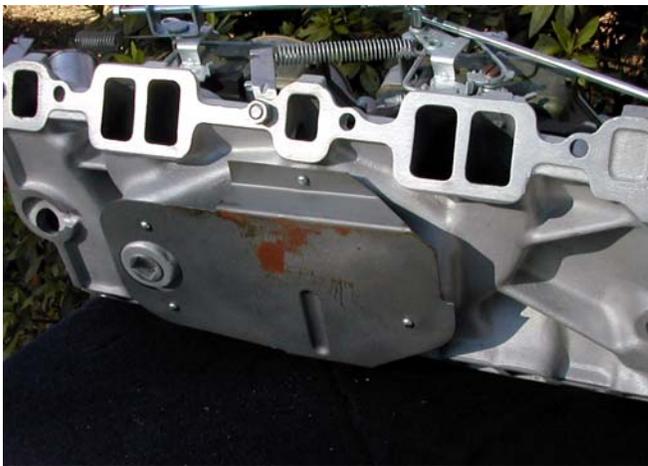
Normally, this code won't be so visible with the shield in place. For example:

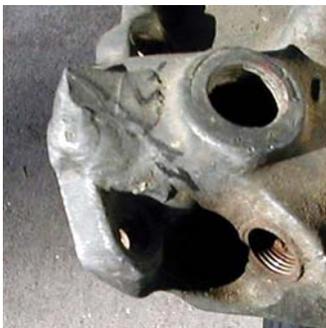
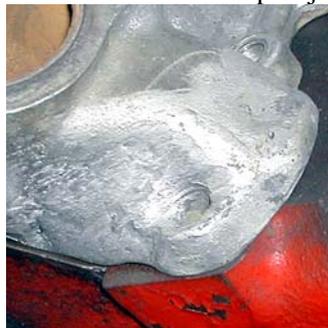
It is rather unlikely that you will find any manifolds in perfect condition. People modified '56 manifolds by grinding out the aluminum between the holes and a great many had the front "ears" broken off and welded back on – depending upon the skill of the welder, the repair may not be terribly obvious. The following pictures show a couple of effective but half **&&%% repair jobs.

Properly done, these manifolds can be repaired and they would certainly be good enough for a daily driver and – maybe, depending on the repair – good enough for an NCRS judged car.

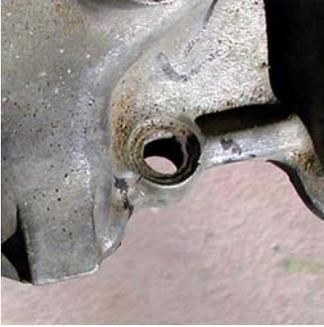
While the broken ears tend to be pretty significant flaws in the manifold, there are less obvious problems. Many of the old manifolds were used on "decked" engines and the manifolds were not matched to the decked engine – as a result, many of the bolt holes where the manifold bolts to the heads were elongated so that the bolts could be inserted. Also, heavy fisted mechanics would often over tighten the manifold and would crack the aluminum around the bolt holes. There are two cracks in this picture.

The cracks are hard to see here but, trust me, they are at 4 and 8 o'clock when viewed from the top.
